**PAVUS, a.s.**

**TEST REPORT ON ROOFS  
EXPOSED TO EXTERNAL FIRE**

**No. Pr-22-2.172-En**

**COMPOSITION OF THE EXTENSIVE GREEN  
ROOF WITH ENVIRET SH**

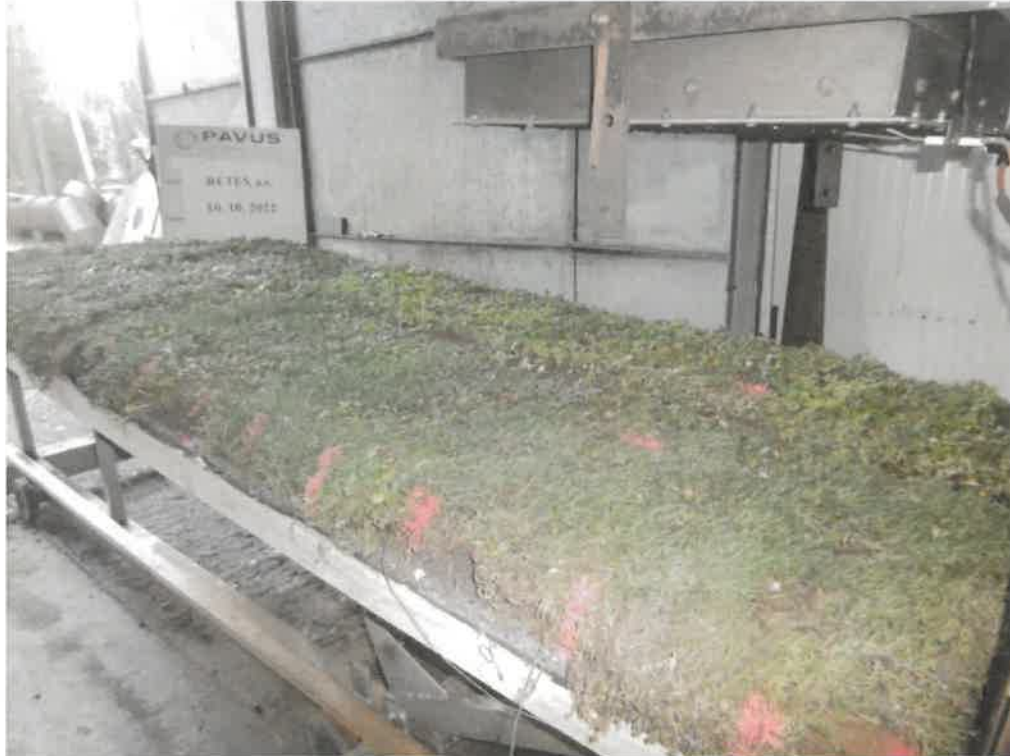
Test specimen No. 1 prior to the test beginning

The subject matter of the test were 2 identical roof specimens of 1,200 x 3,000 mm in size.

Roof assembly composition from the top layer:

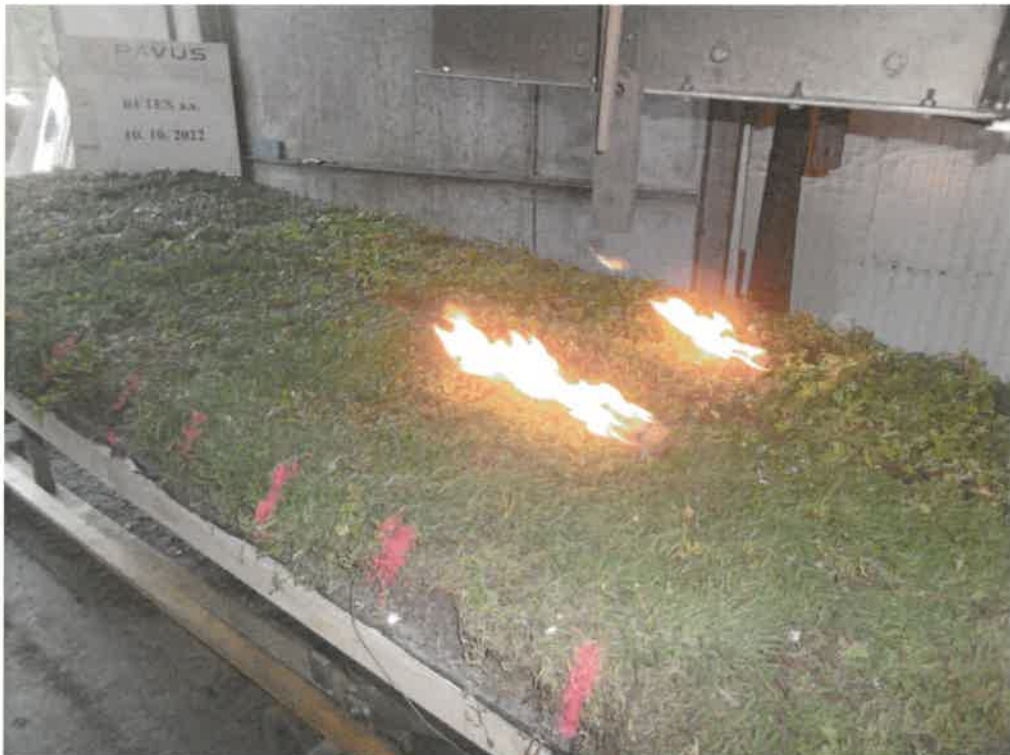
Test specimen No. 1, 7<sup>th</sup> test minute

Time (min)	Observation
0. – 3.	The specimen is exposed to the radiant heat from radiation panel, there are no changes for the surface.
4. – 14.	On the surface the brands are burning, the flame is spreading upwards due to the flow of air from the fan, the plants are burned at the point of the flame and around the brands, the fire is no more spreading, there is a slight development of smoke.
15. – 17.	The brands are burning out, their remnants continue to glow, there is no flame on the surface, the plants begin to get dry and brown under the radiation panel, there is a slight development of smoke.
18. – 30.	There is no flame on the surface, the plants are dry, brown and partially black under the radiation panel, there is a slight development of smoke.
31.	End of test and subsequent specimen opening.

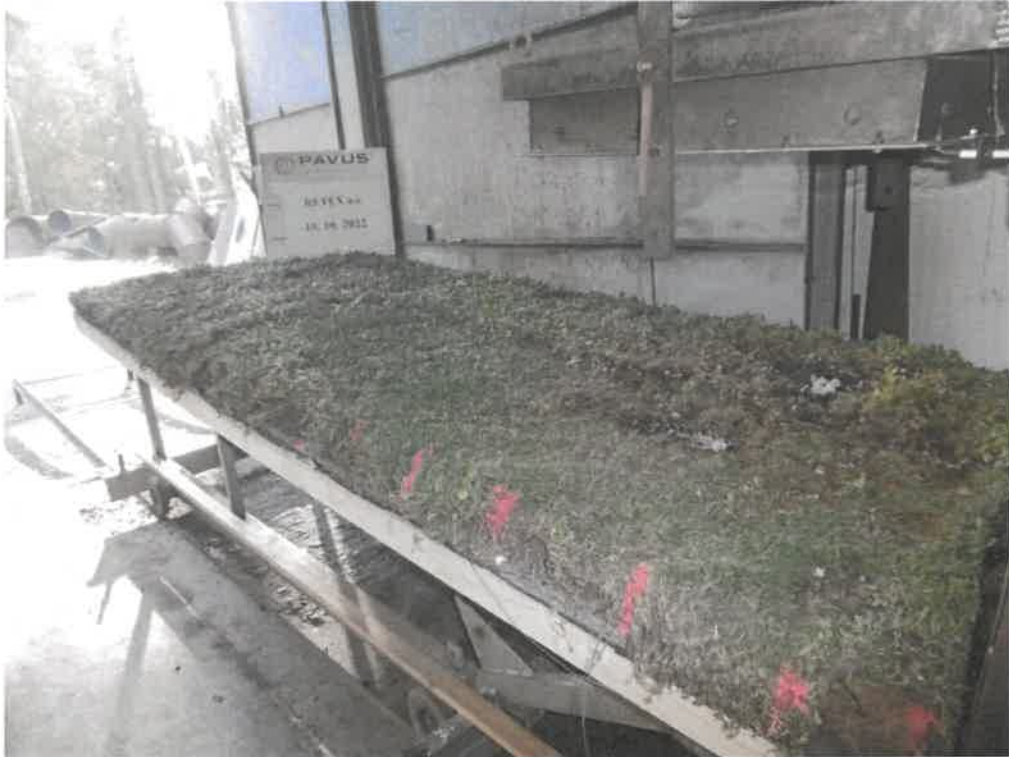
Test specimen No. 1, 16<sup>th</sup> test minute

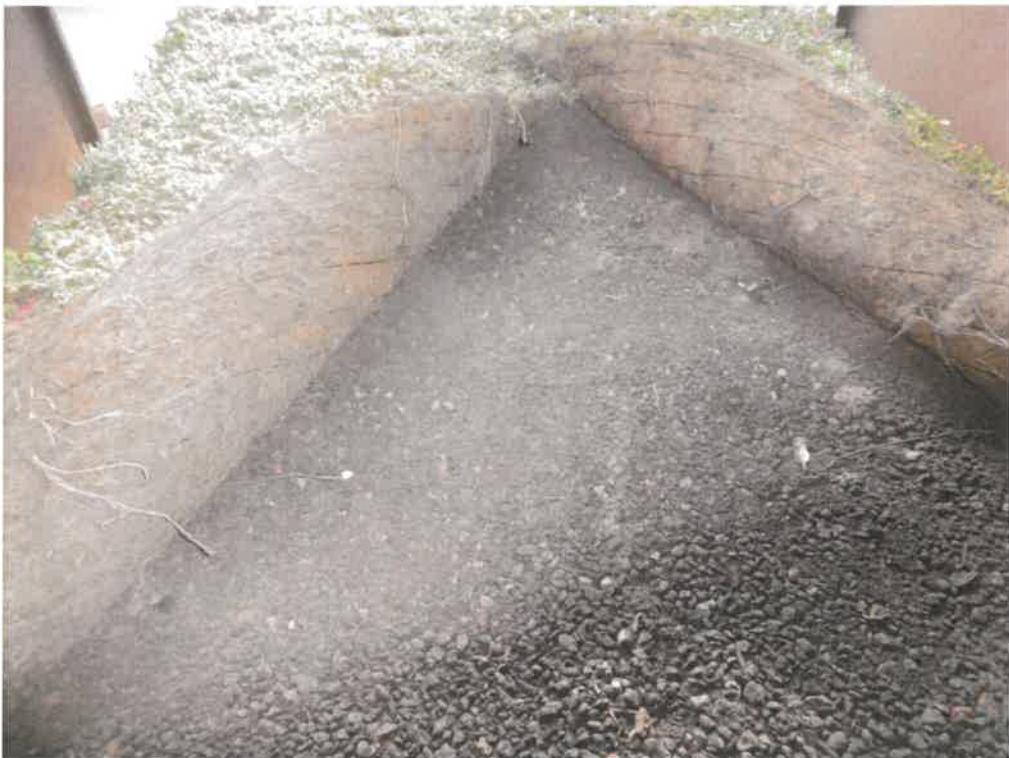
Test specimen No. 1 after opening

Description of damage	Value
Maximum length of burnt material - upwards (mm)	150
Maximum length of burnt material - downwards (mm)	20
Extent of internal damage - upwards - mineral growing medium (mm)	0

Extent of internal damage - downwards - mineral growing medium (mm)	0
Damaged external surface - burnt plants due to the heat (m <sup>2</sup> )	0.77
Falling flaming materials from the surface of the roof	none
Falling flaming materials from the underside	none
Fire penetration, openings	none
