TEST REPORT ON ROOFS EXPOSED TO EXTERNAL FIRE

No. Pr-22-2.173-En

COMPOSITION OF THE EXTENSIVE GREEN ROOF WITH AQUADESK

ČSN P CEN/TS 1187

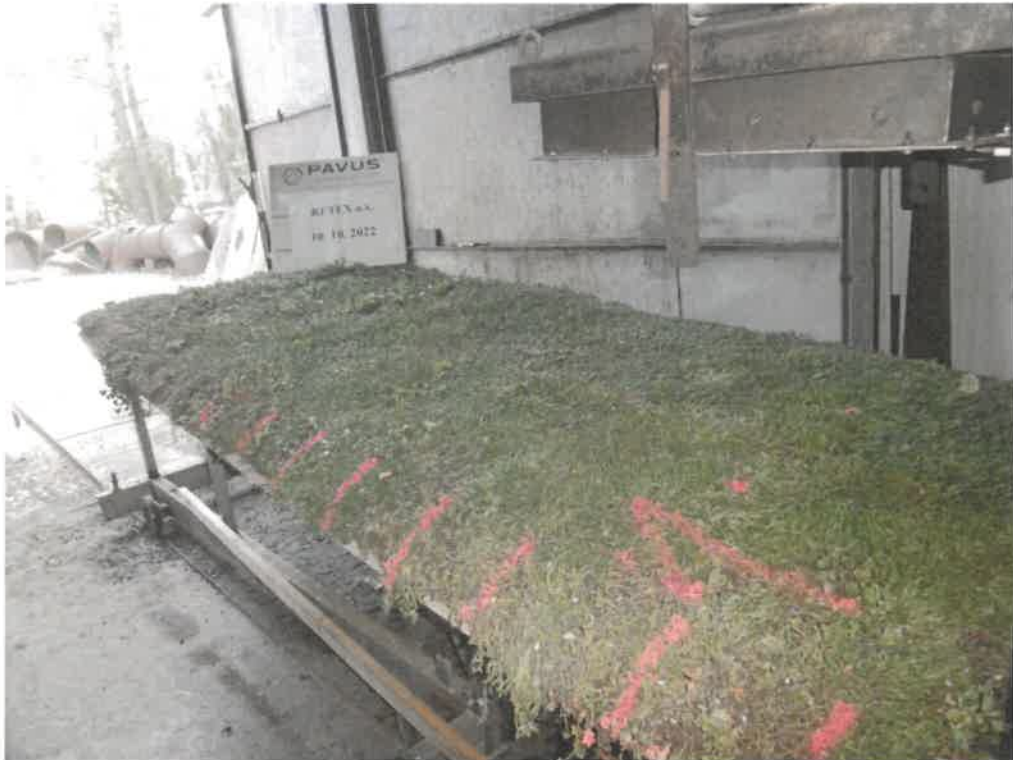
Test specimen No. 1 prior to the test beginning

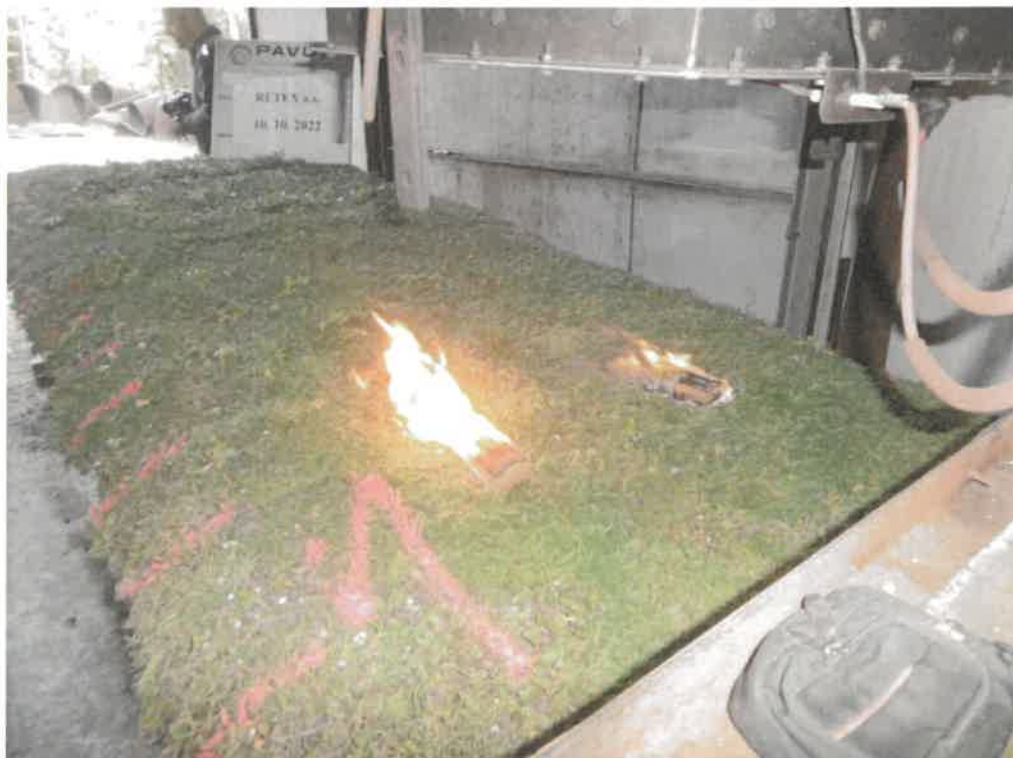
Test specimen No. 1, 9th test minute

Time (min)	Observation
0. – 3.	The specimen is exposed to the radiant heat from radiation panel, there are no changes for the surface.
4. – 15.	On the surface the brands are burning, the flame is spreading upwards due to the flow of air from the fan, the plants are burned at the point of the flame and around the brands, the fire is no more spreading, there is a slight development of smoke.
16. – 20.	The brands are burning out, their remnants continue to glow, there is no flame on the surface, the plants begin to get dry and brown under the radiation panel, there is a slight development of smoke.
21. – 30.	There is no flame on the surface, the plants are dry, brown and partially black under the radiation panel, there is a slight development of smoke.
31.	End of test and subsequent specimen opening.

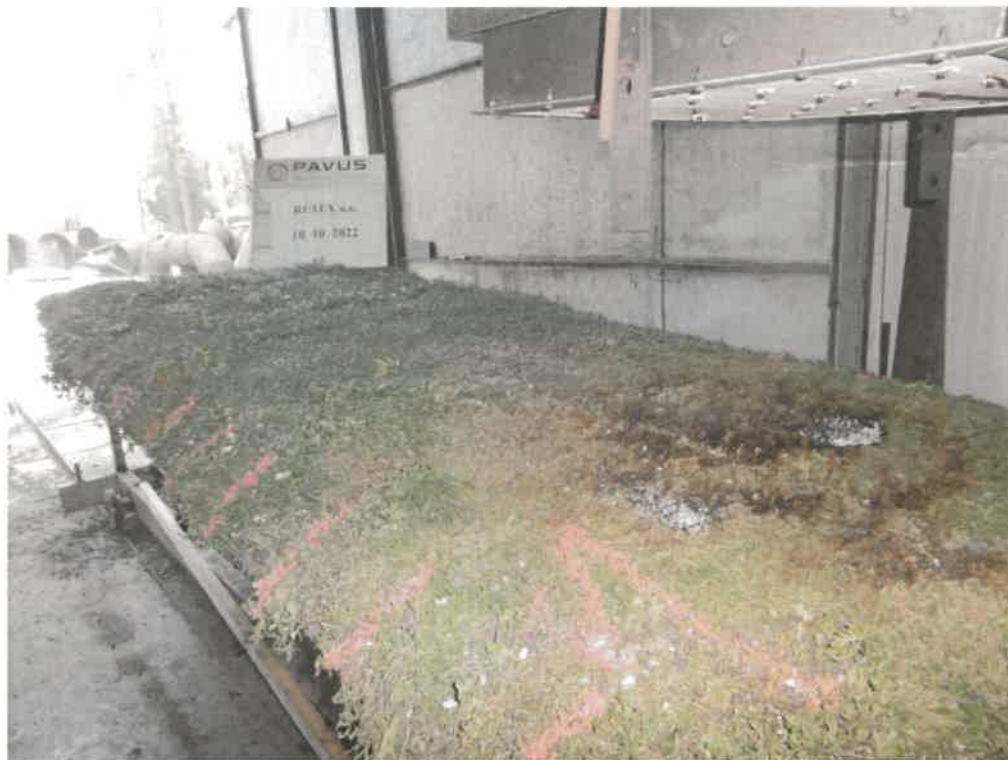
Test specimen No. 1, 19th test minute

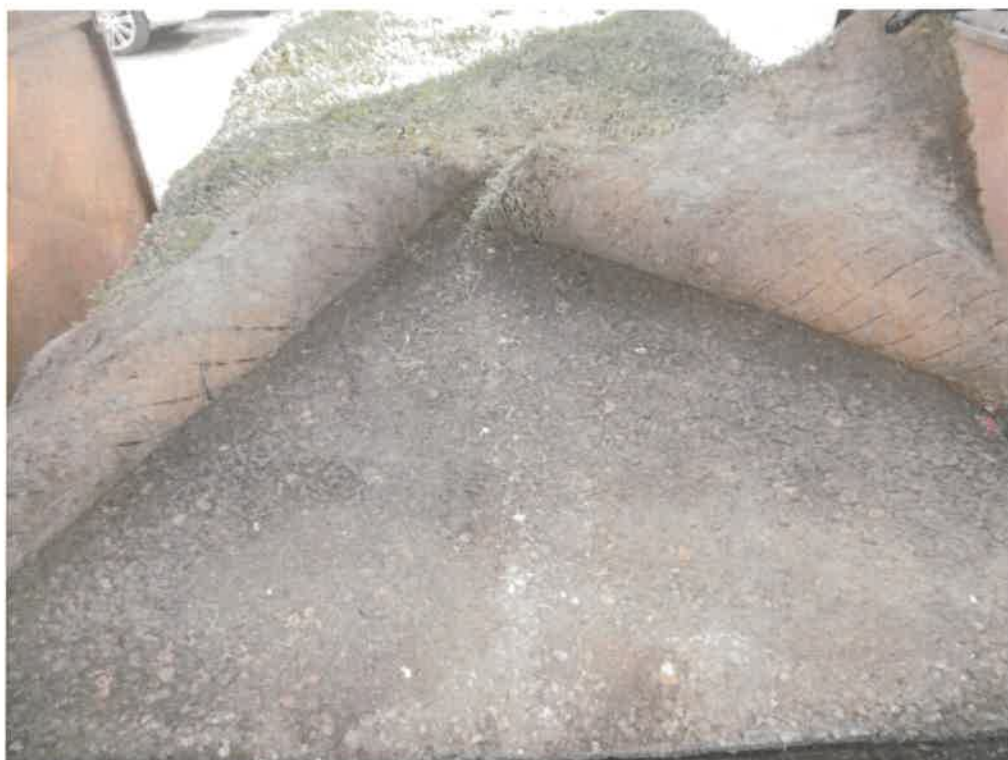
Test specimen No. 1 after opening

Description of damage	Value
Maximum length of burnt material - upwards (mm)	230
Maximum length of burnt material - downwards (mm)	40
Extent of internal damage - upwards - mineral growing medium (mm)	0
Extent of internal damage - downwards - mineral growing medium (mm)	0
Damaged external surface - burnt plants due to the heat (m²)	0.74
Falling flaming materials from the surface of the roof	none
Falling flaming materials from the underside	none
